## TEST REPORT

No. : GZMR250300893701

Sample Name : Premium Magsafe Liquid Silicon Cover (materials: liquid silicon,  
metal buttons & frame, rigid PC lining, and microfiber inside)

Test Item: Drop Test

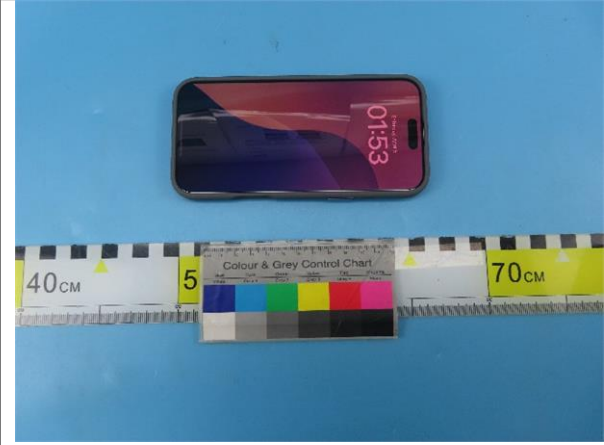
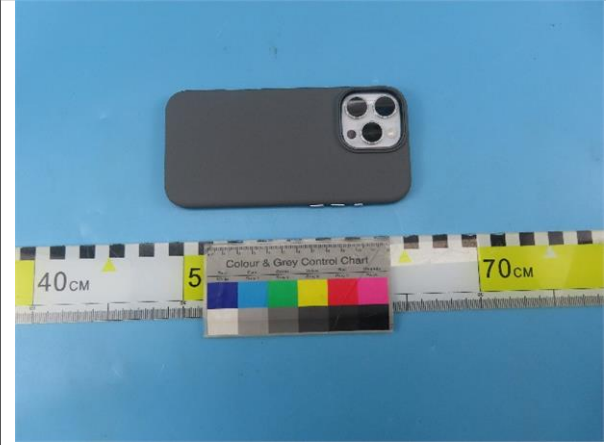
<p>Original Sample-Sample A (Mobile phone installed)</p>	<p>Original Sample-Sample A (Mobile phone installed)</p>

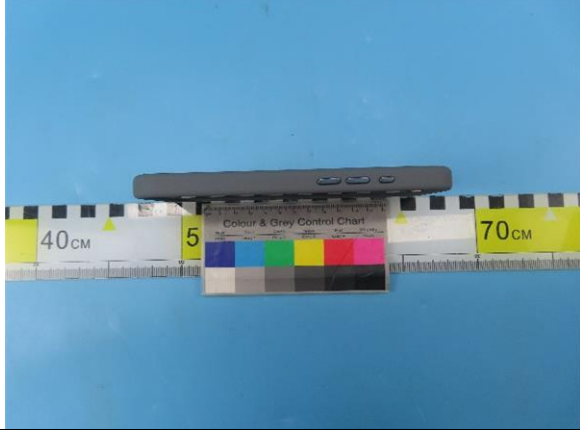
<p>Before test-Sample A (Install the side of the phone case)</p>	<p>After test-Sample A (Mobile phone installed)</p>

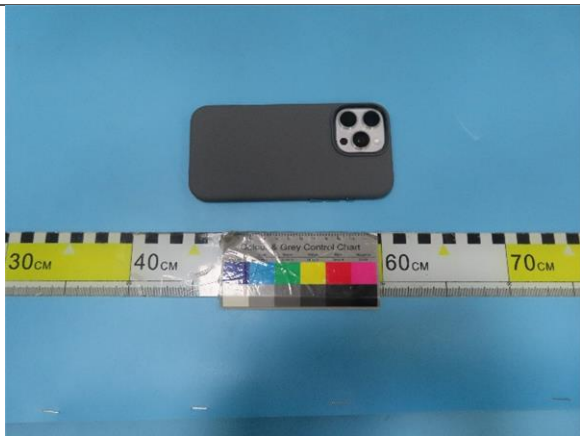
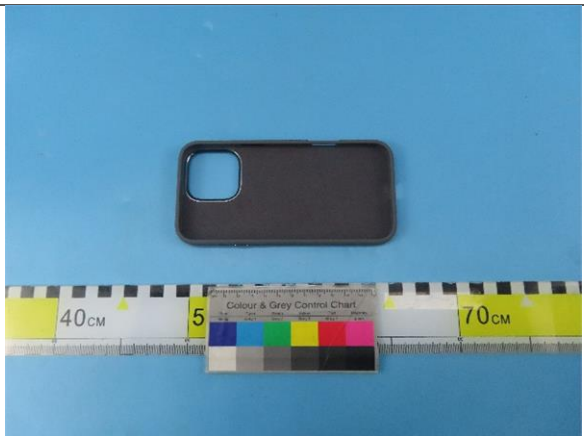
<p>After test-Sample A (Mobile phone installed)</p>	<p>After test-Sample A</p>

Sample No.	Result	Client's requirement	Conclusion
A-1	1. No visible damage to the phone and phone case; 2. The phone would be turned on and off normally, with touch screen buttons and the ability to adjust the volume.	1. No visible damage to the phone and phone case; 2. The phone can be turned on and off normally, with touch screen buttons and the ability to adjust the volume.	Pass

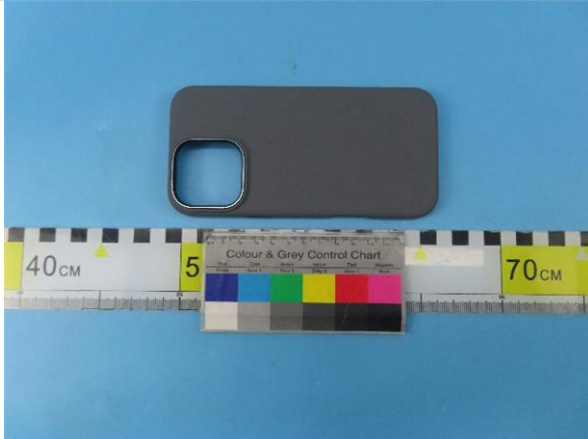
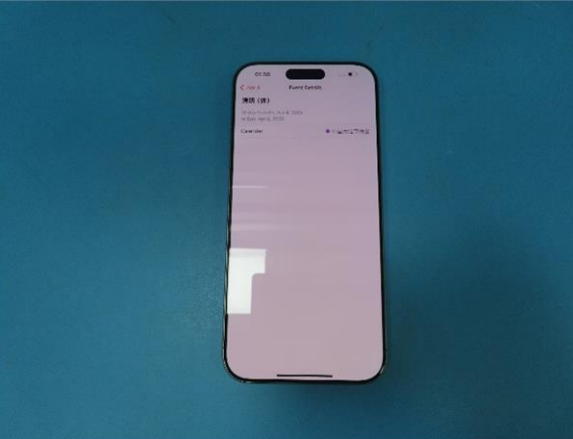
<p>After test-Sample A</p>	<p>After test-Function check</p>

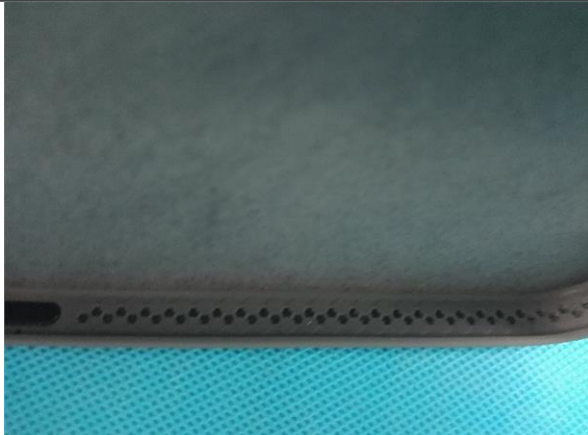
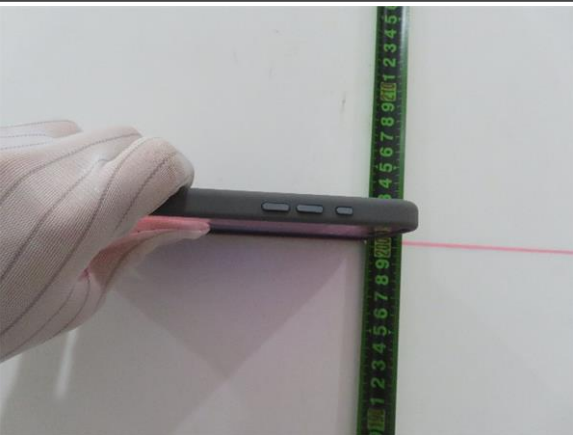
<p>After Test-Local part</p>	<p>During test-Drop face</p>

Drop height: 2 m

Drop plane: Wood plate

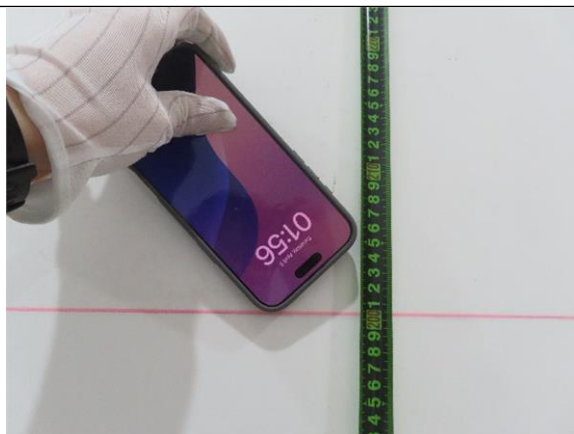
During test-Drop corner

Drop times: Four corners and six faces, a total of 10 times
