TEST REPORT

No. : GZMR250300894501

Sample Name : 2-in-1 magsafe anti-shock cover for iPhone 16 Pro Max (soft TPU core, and outer rigid PC shell)

Test Item: Drop Test

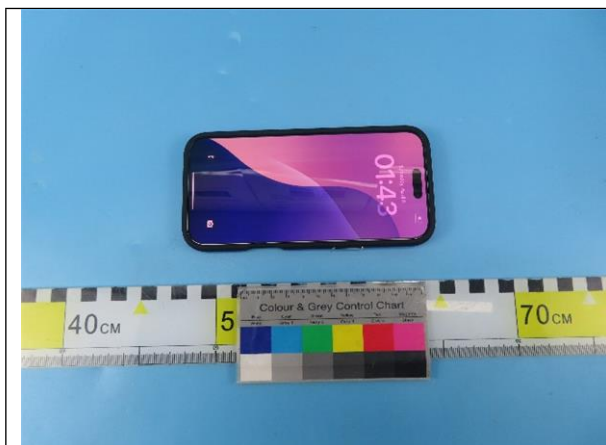
Original Sample-Sample A
(Mobile phone installed)

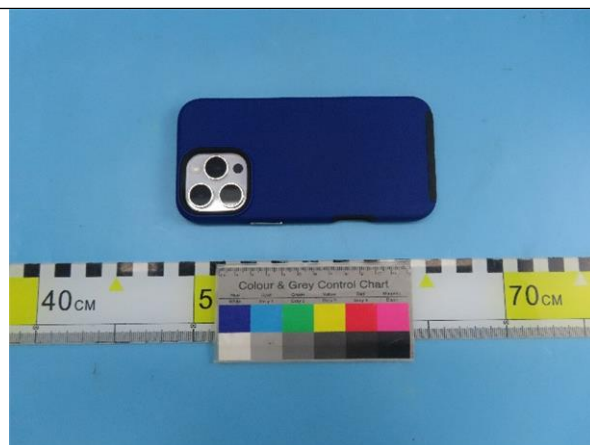
Original Sample-Sample A
(Mobile phone installed)

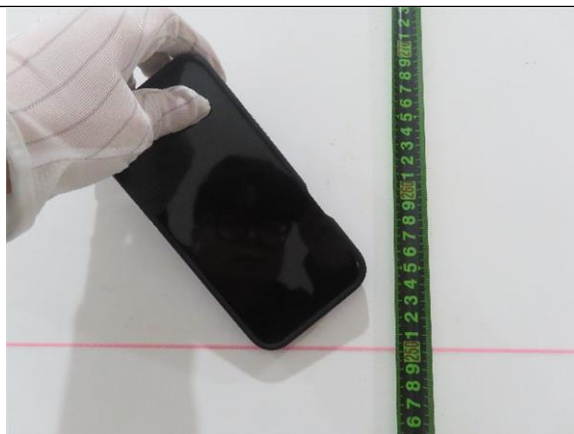
During test-Drop corner

Drop height: 2.5 m

Drop plane: Wood plate

Drop times: Four corners and six faces, a total of 10 times
